Piston damages

Recognising and rectifying

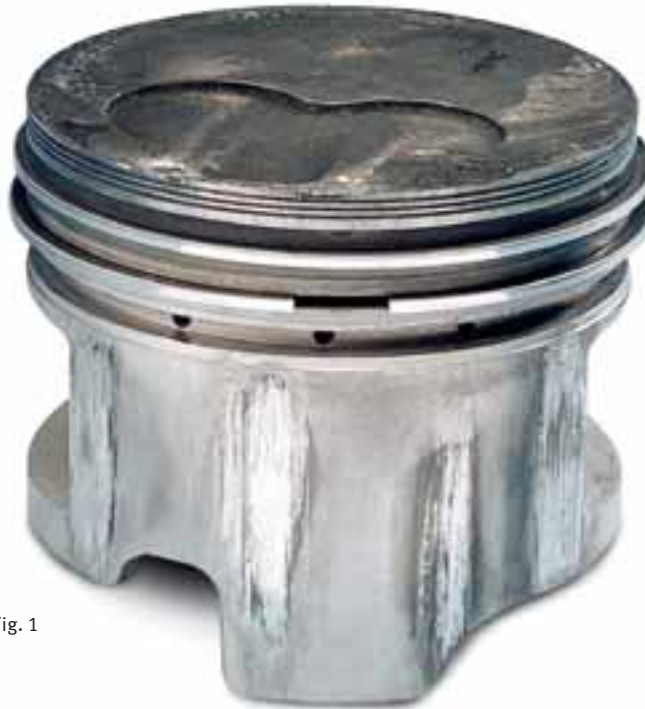
Fig. 1

The seizure marks can be found on both the pressure side and on the counterpressure side, i.e. there are corresponding counter-seizure marks on one side of the piston to match the seizure marks on the other. The surface of the seizures gradually changes from highly polished pressure areas to darkly discoloured areas of wear caused by rubbing. The ring zone is undamaged.

In contrast to seizure caused by lack of lubrication, seizure due to insufficient clearances always occurs after a brief running-in period after an engine overhaul.

- Cylinder bore too small
- Cylinder head overtightened or tightened unevenly (cylinder head distortion)
- Uneven sealing surface on the cylinder or on the cylinder head
- Dirty or distorted threads in the threaded bores or on the cylinder head bolts
- Seized or insufficiently lubricated bolt head contact surfaces
- Use of incorrect or unsuitable cylinder head gaskets
- Cylinder head distortion caused by uneven heating due to deposits, dirt or other problems in the cooling system.

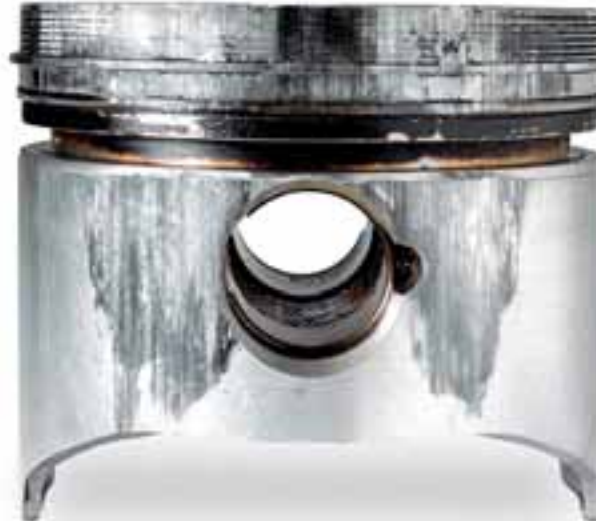
Fig. 1

Seizure marks at an offset of approximately 45° to the piston pin axis which are found both on the pressure side and on the counterpressure side are characteristic of this type of damage. The surface at the seizures gradually changes from highly polished pressure areas to relatively smooth, darkly discoloured areas of wear caused by rubbing. The piston pin displays blue tempering colours; which indicates in this case that the piston pin bed must have become hot due to insufficient clearances or a lack of oil.

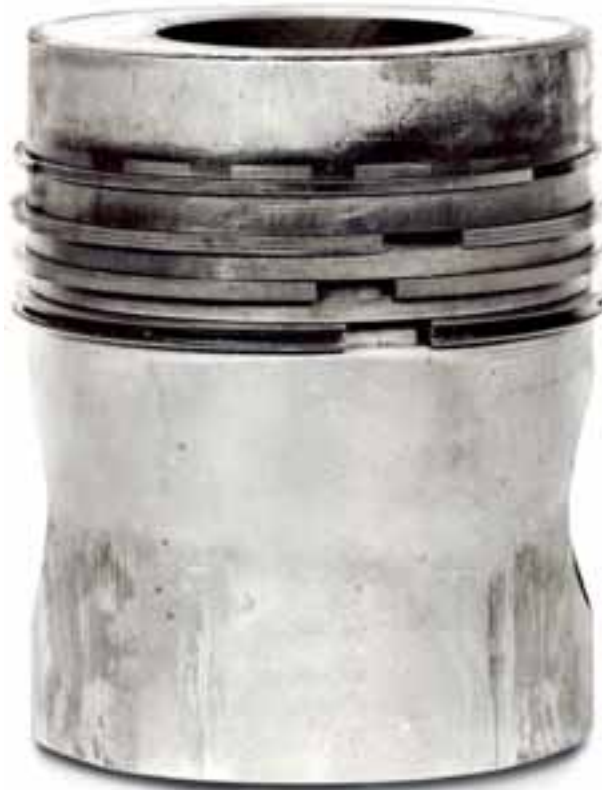
Fig. 1

The piston displays typical seizure marks caused by insufficient clearances at the bottom end of the skirt, with pressure marks and counterpressure marks. The marks change from highly polished pressure points to smooth, darkly discoloured areas of wear caused by rubbing. (Fig. 1) There is nothing unusual about any of the remaining parts of the piston. The matching wet cylinder liner (Fig. 2) displays seizure marks of exactly the same nature in the lower part where the outer diameter is sealed with several sealing rings against water and oil in the crankcase.

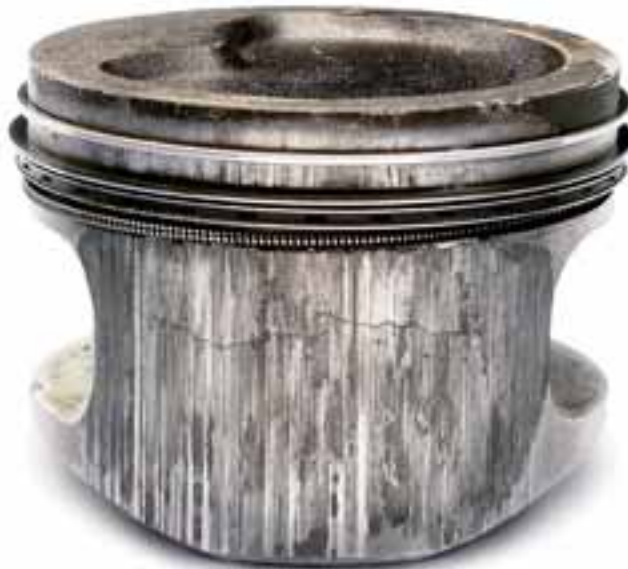
Fig. 1

Darkly discoloured seizure areas with a severely worn surface are present on one side of the piston skirt. Due to the high temperatures on the piston (Fig. 1), large areas of piston material have been torn out from the surface of the piston skirt panel in the area of the seizure. The broken edge at the same height as the piston pin shows this clearly. In this scenario, it is completely typical for the side of the piston skirt opposite the seizure area to be completely free of damage, and the same applies in the early stages at least to the ring zone as well.

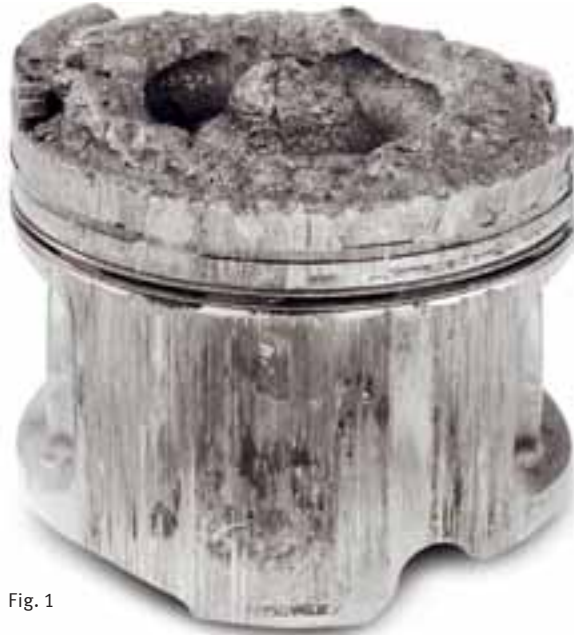
Fig. 1

The crown area and the piston top land area have been completely destroyed (Fig. 1). The piston top land has melted away as far as the ring carrier. Melted-away piston material has been worn down on the piston skirt where it has also caused damage and seizure marks. The ring carrier of the first compression ring is now only partially intact on the left-hand side of the piston. The rest of the ring carrier has become detached from the piston during operation and caused further damage in the combustion chamber. The force of the parts flying around has transported them through the intake valve into the intake manifold and from there into the neighbouring cylinder, where they have caused further damage (impact marks).

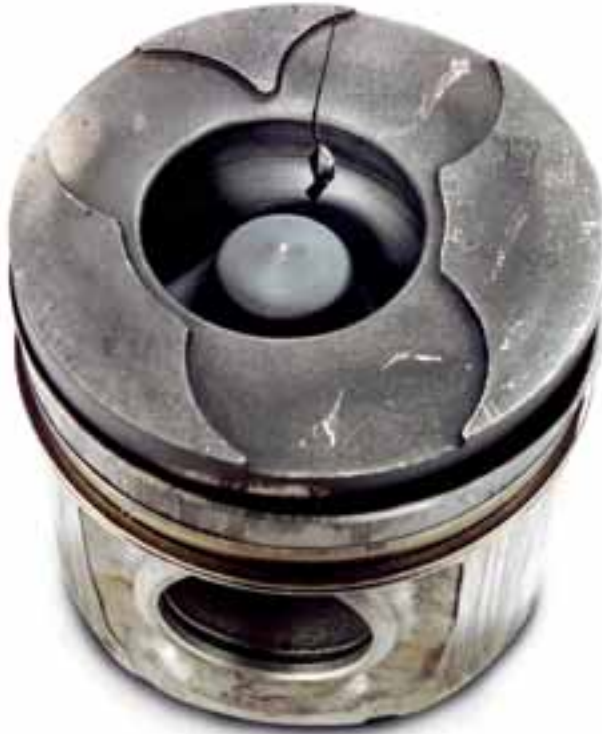
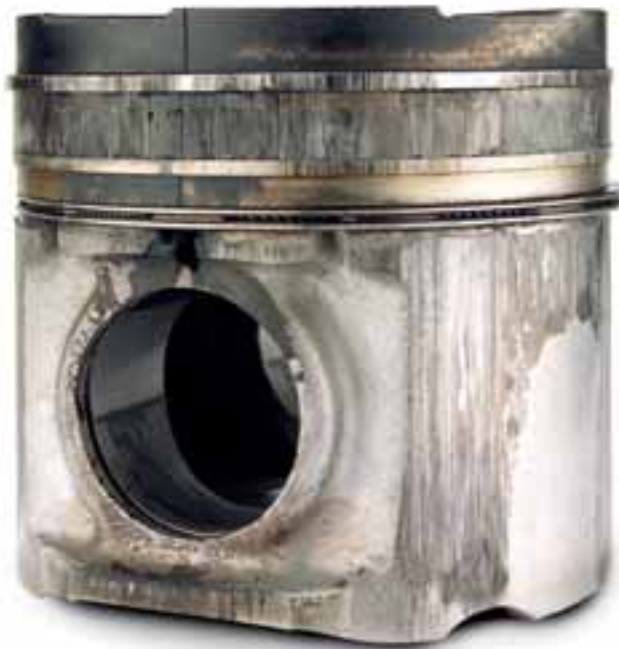
The piston crown displays a stress crack which extends on one side from the piston crown to the piston pin boss (Figs. 1 and 2). The hot combustion gases which have flown through the crack have burned a channel into the piston material which runs outward from the bowl to the cast bowl below the oil scraper ring.

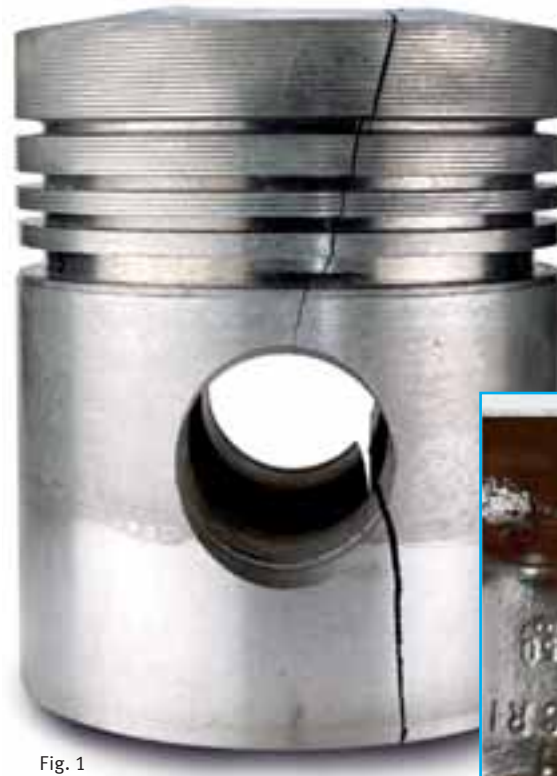
The early stages of a typical pin boss fatigue crack are evident in the centre axis of the piston pin bore (Fig. 2). The crack has spread in a semicircle around its starting point. A so-called cleavage fracture forms from the initial crack, which splits the piston up to the piston crown into two parts – as can be seen in Fig. 1 (the piston has been sawed

open from the bottom for the purposes of investigation; the original crack extended from the piston pin bore to the piston crown).

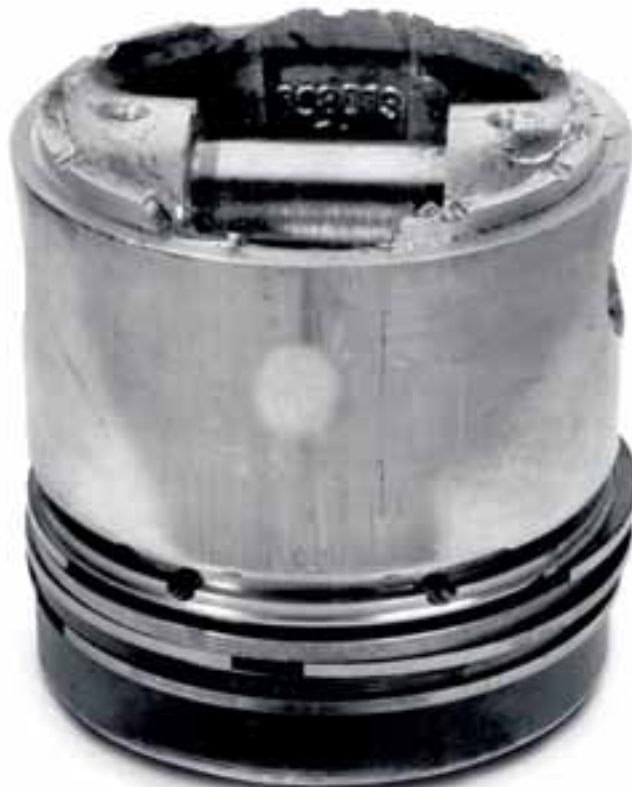
On the piston in Fig. 2 the piston skirt has broken off in the lower oil scraper ring groove. The surfaces at the fracture display the characteristics of a fatigue fracture.

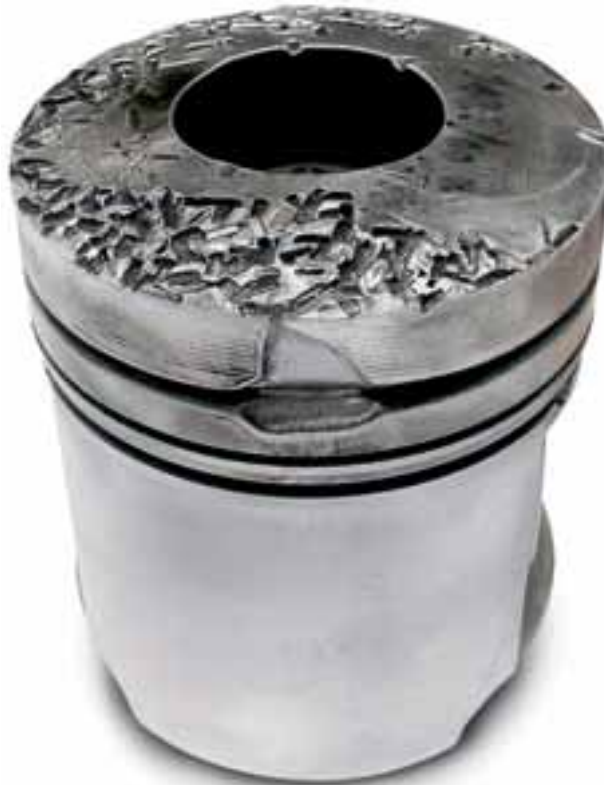
Fig. 1

Severe material washout reaching as far as the piston crown is evident in the ring zone in the area of the first ring groove. The ring groove displays severe axial wear. Heavy imprints from broken fragments of the first ring can be seen on the piston crown. In some places the running pattern of the piston skirt has a matt, buffed appearance.

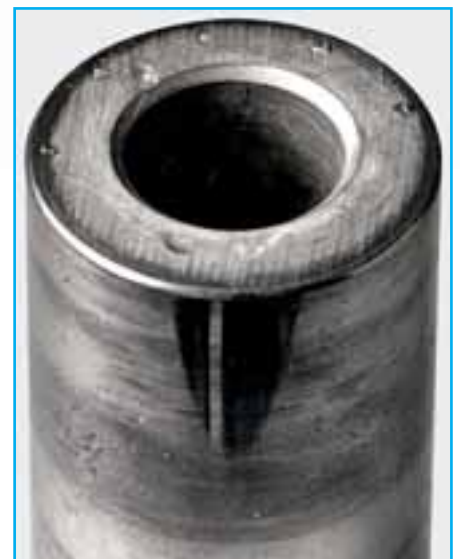
Fig.2

Fig. 2 shows that an incipient crack can not only be caused by an excessive load, but also as a result of improper handling of the piston pin during installation. The end face of the broken piston pin clearly shows that the incipient fracture was caused by impact damage due to a blow, e.g. from a hammer. As can be seen from the above descriptions, even under normal load conditions any incipient fracture can develop as a fatigue fracture and ultimately lead to total breakage of the piston pin.

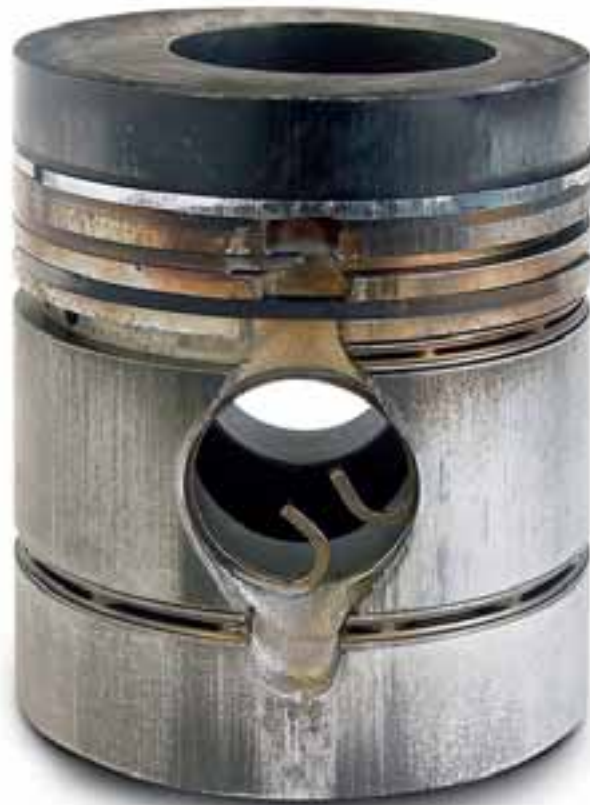
Fig. 1

When the piston was removed there was no longer a circlip in the retaining groove. It had jumped out during operation and broken into fragments. Although the second circlip is damaged, it was still installed in its groove when the piston was removed. Due to the lack of retention, the piston pin has wandered outwards during operation towards the cylinder running surface. Clearly the front face of the pin has had prolonged contact with the cylinder running surface. As a result, the front face is worn to a convex shape (Fig. 3). The running pattern of the piston is formed very asymmetrically.

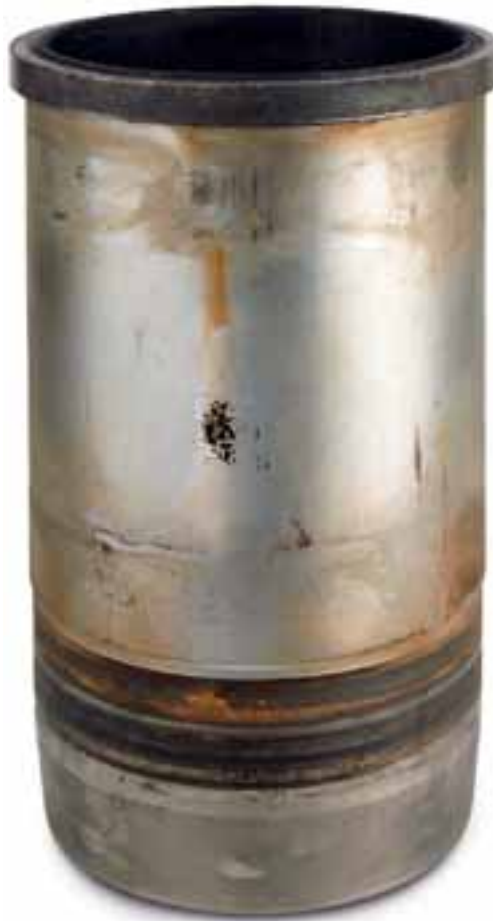
Fig. 1

The wet cylinder liner displays severe cavitation in the area of the water jacket. The damage has progressed so far that there is already one hole into the inside of the cylinder.

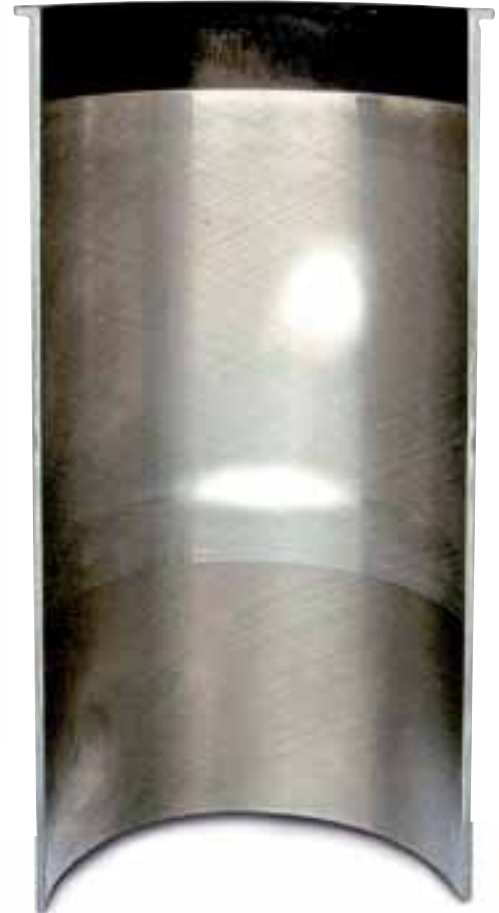
Fig. 2

The cylinder bores display an uneven wear pattern with individual brightly polished areas (Fig. 2). No wear or rubbing marks are evident on the pistons. The engine was losing oil at the sealing points, in particular the radial oil seals. Fig. 1 clearly shows the corrosion on the outer diameter of the cylinder liner which caused the out-of-roundness of the cylinder when it was installed.

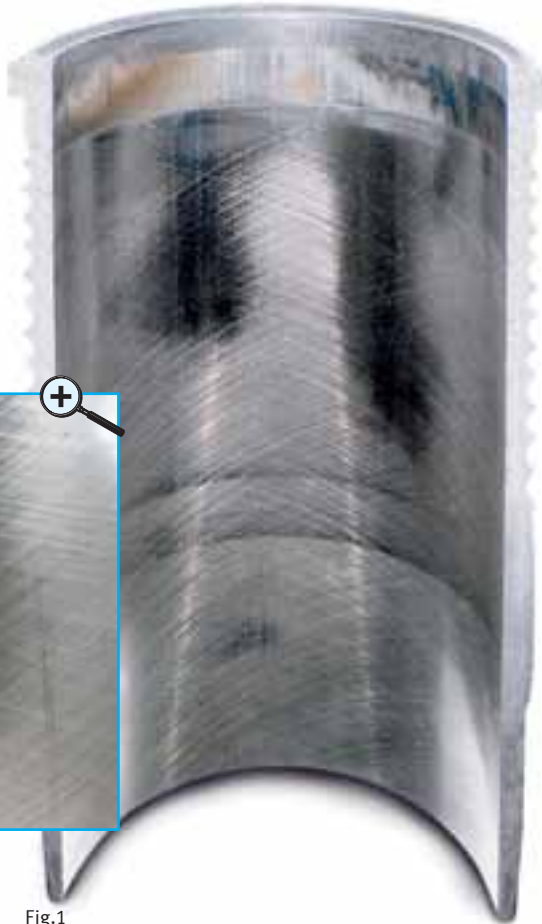
Fig.1

In its upper area, the cylinder running surface has highly polished, bare areas in which the honing structure is completely unrecognisable (Fig. 1 and Fig 2). There are no significant signs of wear on the piston itself. The engine is consuming increased quantities of oil.

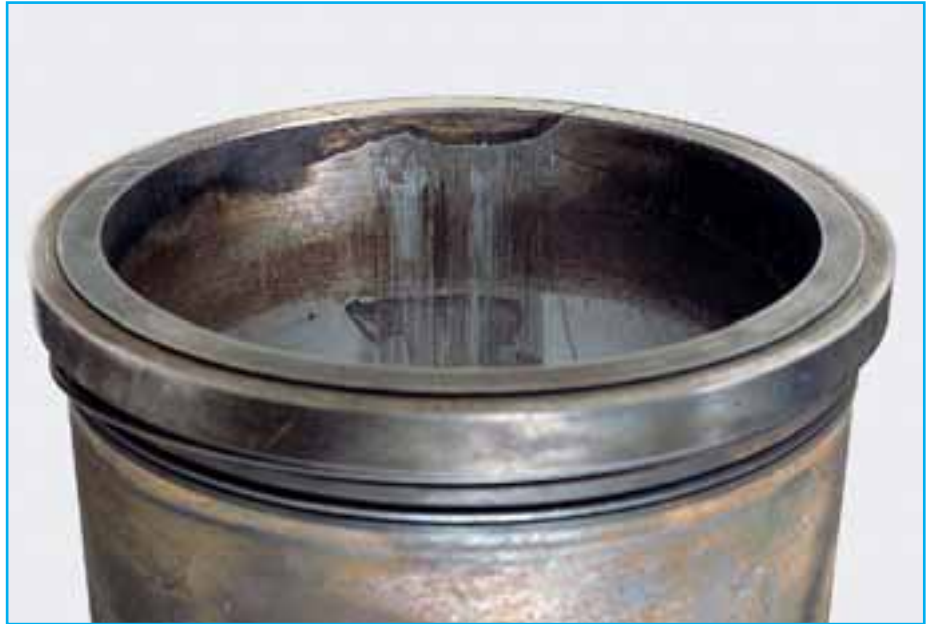
Fig. 1

The cylinder liner displays severe damage due to a crack in its upper area, together with seizure marks on the running surface (Figs. 1 and 2). The associated piston also displays seizure marks on the pressure and counterpressure side. A trough-shaped indentation in the piston crown has formed in the area where the seizure marks are present on the skirt (Fig. 3).

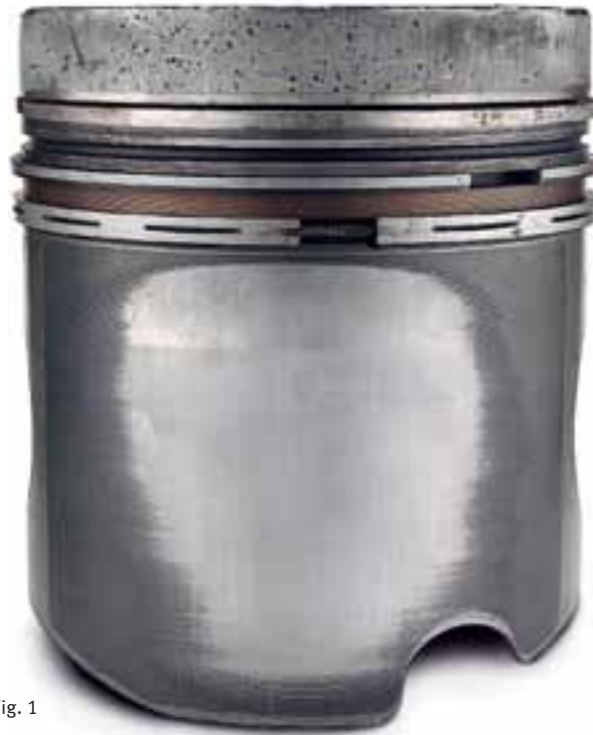
Fig. 1

The piston displays signs of wear on the piston top land and the piston skirt. Rubbing marks can already be seen on the piston skirt which are characteristic for dry-running due to fuel flooding. The piston rings display very severe radial wear (Fig. 1). Both of the webs (support surfaces) on the oil scraper ring have been completely worn down, which also indicates significant wear (Fig. 2). By comparison, Fig. 3 shows the profile of a new and worn oil scraper ring (double bevelled spiral expander ring).

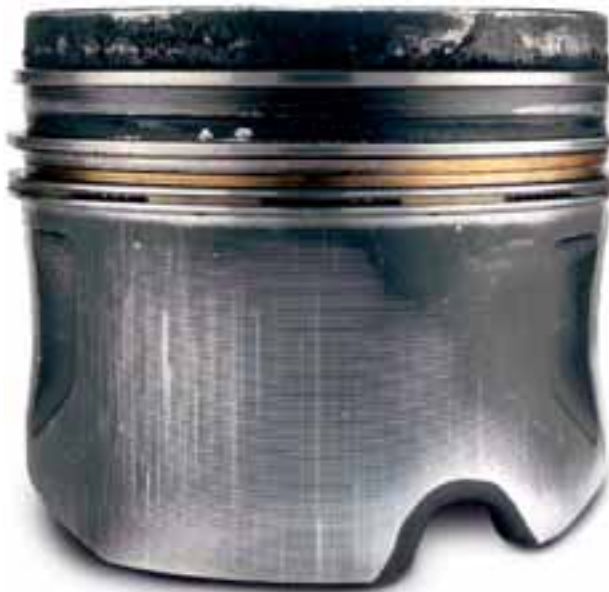
Fig. 2 also shows an example of a piston which has not run perfectly straight. However, in this case the main area which has been worn is on the lower right-hand edge of the piston around the cutout for the cooling oil nozzle, rather than around the piston top land.
