Piston damages

Recognising and rectifying

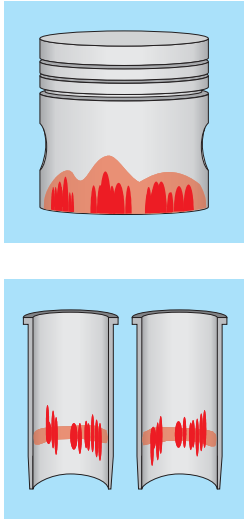
Fig. 1

The piston displays typical seizure marks caused by insufficient clearances at the bottom end of the skirt, with pressure marks and counterpressure marks. The marks change from highly polished pressure points to smooth, darkly discoloured areas of wear caused by rubbing. (Fig. 1) There is nothing unusual about any of the remaining parts of the piston. The matching wet cylinder liner (Fig. 2) displays seizure marks of exactly the same nature in the lower part where the outer diameter is sealed with several sealing rings against water and oil in the crankcase.

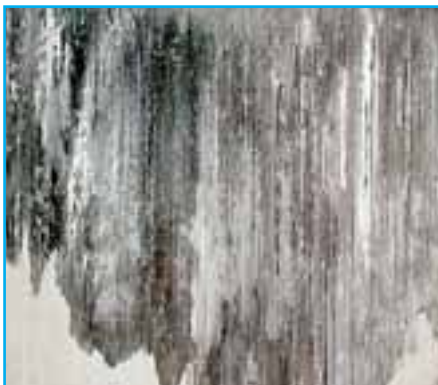
a) If the oil film is destroyed altogether:

seamless areas of narrow seizure marks mainly on the piston skirt, showing a severely worn and darkly discoloured surface. In the early stages there are often no matching seizure marks on the opposite side of the piston.

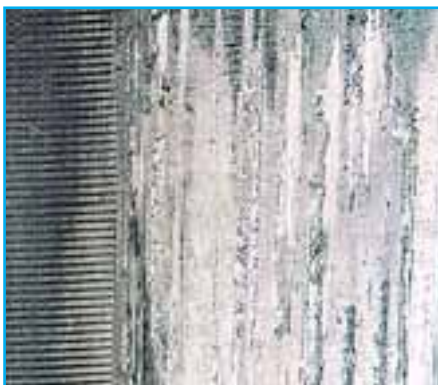
b) If there is a lack of oil:

identical to the seizure marks due to lack of lubrication described above, apart from the discoloration of the surface. The surface of the seizure areas almost has a pure metallic finish, with no dark discoloration. As the lack of oil affects the entire surface of the cylinder, there are often seizure marks on both the pressure side and the counterpressure side, even in the early stages.

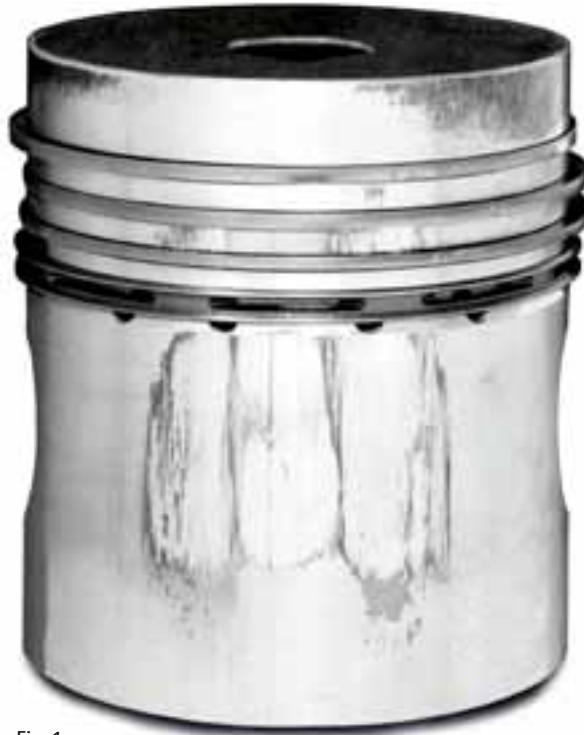
Fig. 1

Seizure marks which in some cases extend into the ring zone are present in the running surface area where normally the wear pattern develops. Slight counter-seizure areas have occurred on the opposite side of the skirt. The surface of the seizure areas has no dark discoloration and almost has a pure metallic finish.

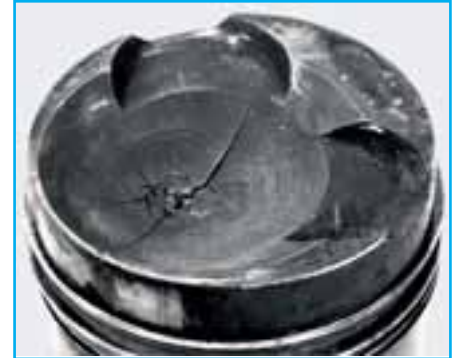
Fig. 3

In the areas where before the material was buckled and forced away, there is now suddenly a shortage of material. This results in tensile stresses in this area which ultimately cause stress cracks (see Figs. 3 and 4). If in addition to the stresses resulting from the thermal overload there are also superimposed stresses caused by warping of the piston pin, then in some cases the stress cracks can turn into a much larger major crack which causes complete breakage and failure of the piston.

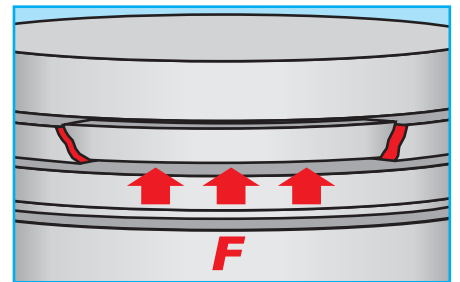
Fig. 4

During installation, the piston was knocked in rather than being slid in, because the piston rings were not correctly compressed or unsuitable tools were used. In this case the ring lands fracture in the reverse direction as the pressure comes from below (Fig. 4), not from above as in the above case.

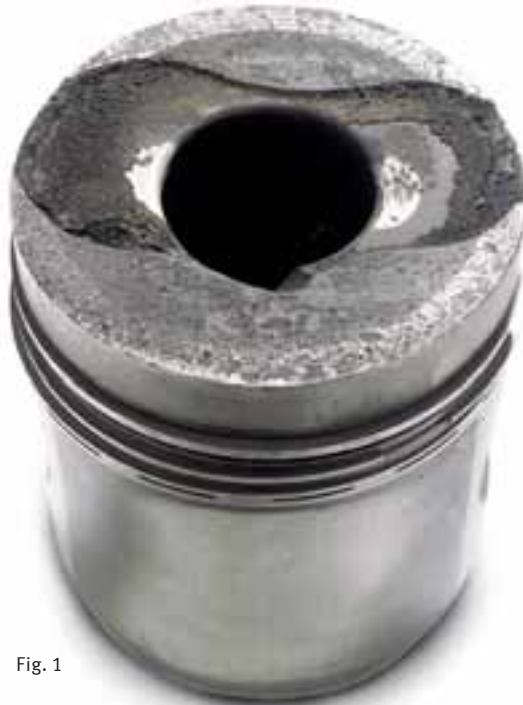
Fig. 1

Severe impact marks can be seen on the piston crown (Fig. 1). Nearly all of the oil carbon deposits have been removed from this area due to metallic contact between the piston and the cylinder head. The oil carbon deposits have been pressed into the piston crown as a result of the impacts, leaving scarring in the process. The piston rings indicate signs of severe wear. The wear is evident even to the naked eye on the oil scraper ring in particular.

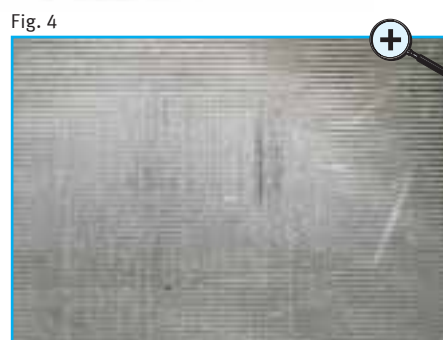
Fig. 4

On the piston shown in Fig. 2, an imprint of the swirl chamber can be seen on the front edge of the crown, and a strong imprint of the valve can be seen on the right-hand side of the crown. This means that, as well as the swirl chamber, a valve has also made contact with the piston crown during operation, and the valve has gradually dug itself into the piston crown (see Fig 3). First indicators of rubbing marks due to a lack of lubrication are evident on the piston skirt (see Fig. 4).

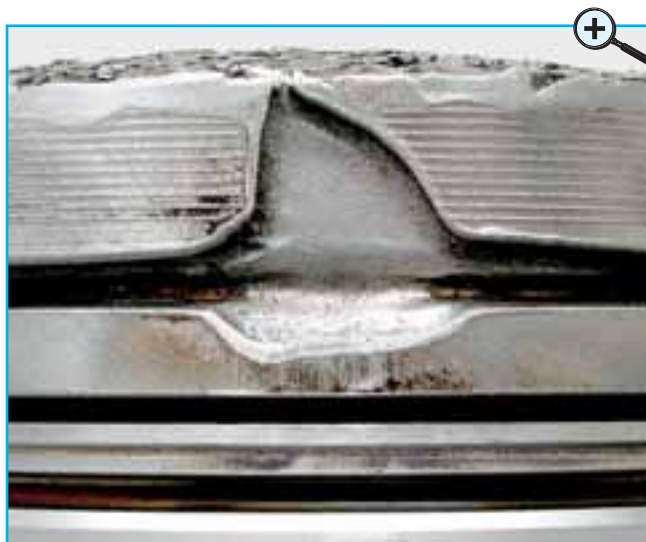
Fig. 2

Severe material washout reaching as far as the piston crown is evident in the ring zone in the area of the first ring groove. The ring groove displays severe axial wear. Heavy imprints from broken fragments of the first ring can be seen on the piston crown. In some places the running pattern of the piston skirt has a matt, buffed appearance.

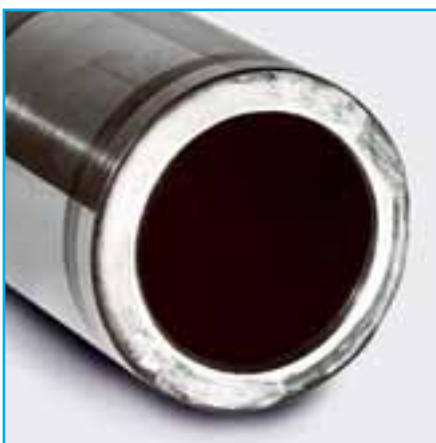
Fig. 3

When the piston was removed there was no longer a circlip in the retaining groove. It had jumped out during operation and broken into fragments. Although the second circlip is damaged, it was still installed in its groove when the piston was removed. Due to the lack of retention, the piston pin has wandered outwards during operation towards the cylinder running surface. Clearly the front face of the pin has had prolonged contact with the cylinder running surface. As a result, the front face is worn to a convex shape (Fig. 3). The running pattern of the piston is formed very asymmetrically.

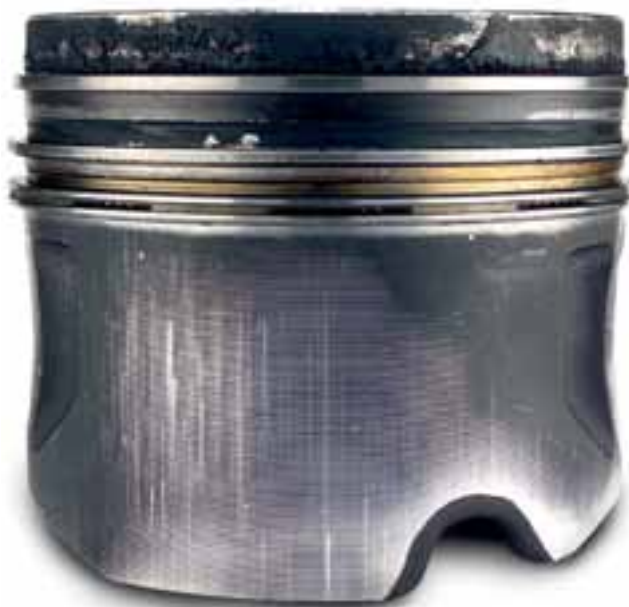
In this case the piston has been running at an angle, which has also caused the piston pin circlip to be hammered out. As a result of the piston running at an angle in the cylinder and the one-sided load on the piston pin, the piston pin has broken (Fig. 6), and subsequently the piston has been broken as well (Fig. 5). The asymmetrical running pattern resulting from the piston running at an angle can be seen very clearly in Fig. 4 .

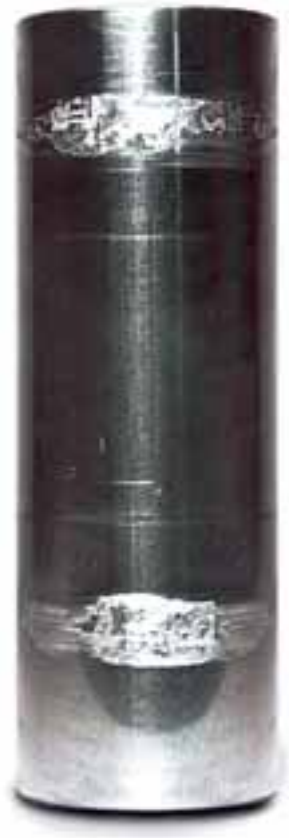
Fig. 1

floating-fit piston pin is too small for this. The increased friction caused excessive overheating in the bearing, as a result of which the oil film became ineffective and the piston pin seizure arose.

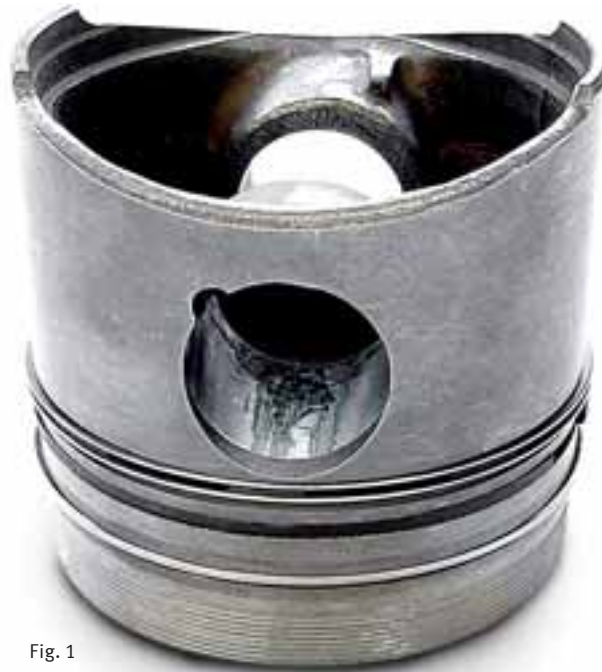
Fig. 1

This piston has clearly only run for a short length of time. Neither a deposit on the crown nor any running marks can be seen. The piston pin has seized in both piston pin eyes on the upper side, i.e. the side under pressure load (Fig. 1). The surface at the seizures is clean bare metal. No traces of burned-in oil are evident.

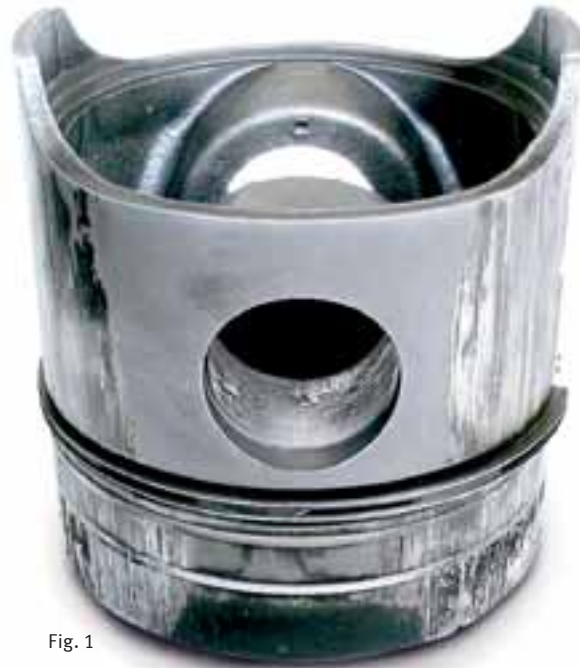
Fig. 1

As the main focus of the seizures is on the piston top land, it is safe to assume that this is where the damage obviously originated as a result of abnormal combustion. Subsequently the

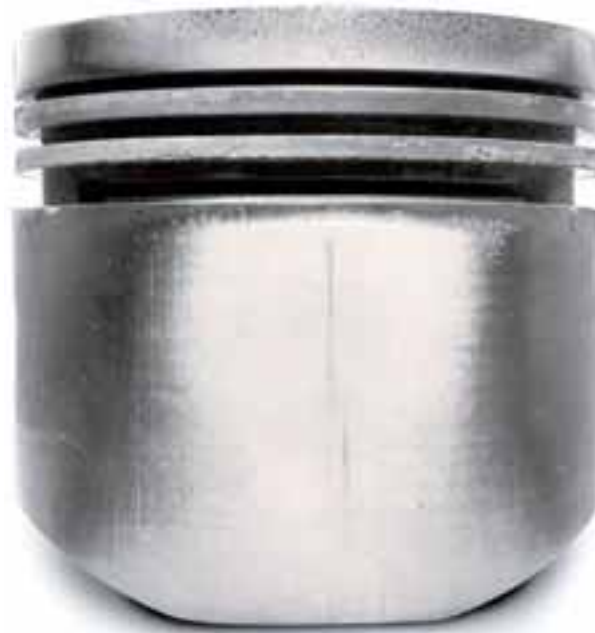
Fig. 1

One type of piston noise which is perceived as particularly annoying is caused by the piston crown striking

alternating sides of the cylinder running surface. Depending on the cause, the piston top land strikes either in

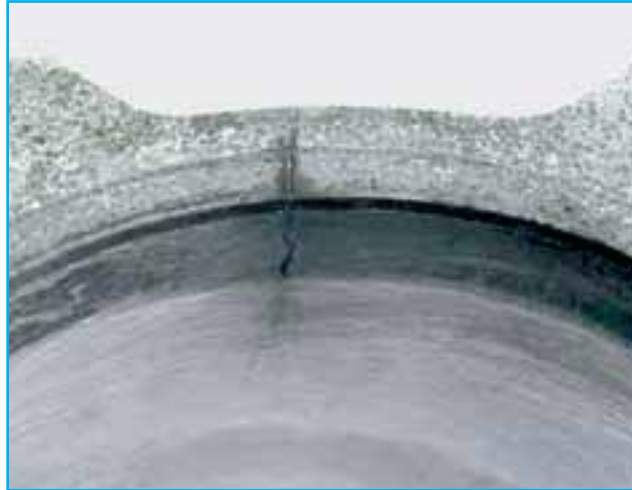
Fig. 1

The crack is usually vertical and usually extends in a vertical direction from the liner flange. Dry liners can also be affected because of their relatively thin cylinder wall thickness.

Cylinder liner cracks of this nature are frequently caused by careless handling (e.g. the results of impacts or blows). Even if the liner does not suffer visible damage straight away, a microscopic crack or notch can

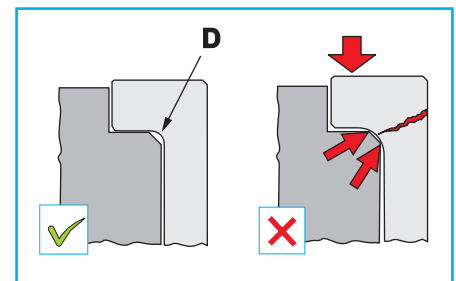
Furthermore, it must also be ensured that the shape of the liner seat radius (D) in Fig. 4 is not chosen so large as to prevent the liner from bearing loads at the inner or outer edge on the liner flange.

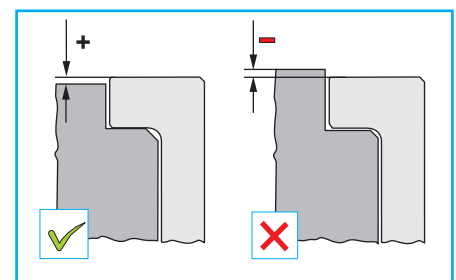
Fig. 6

- If the liner flange does not project by the prescribed dimension from the cylinder sealing surface, or if it is slightly recessed (Fig. 6), then the liner is not pressed onto the liner seat with enough force during installation. During operation, this can cause the liner to also adopt a pendulum motion as a result of the pendulum motion of the piston. The resulting forces acting on the liner flange can cause it to be torn off. If it is necessary to rework the liner flange contact surface during a major engine overhaul, it is possible to either insert steel adjustment shims underneath or use a liner with an oversized flange to provide the necessary protrusion of the liner over the cylinder surface. The solution involving a liner with oversized flange* is preferable to the option of inserting adjustment shims underneath, as it is technically the more sturdy solution.

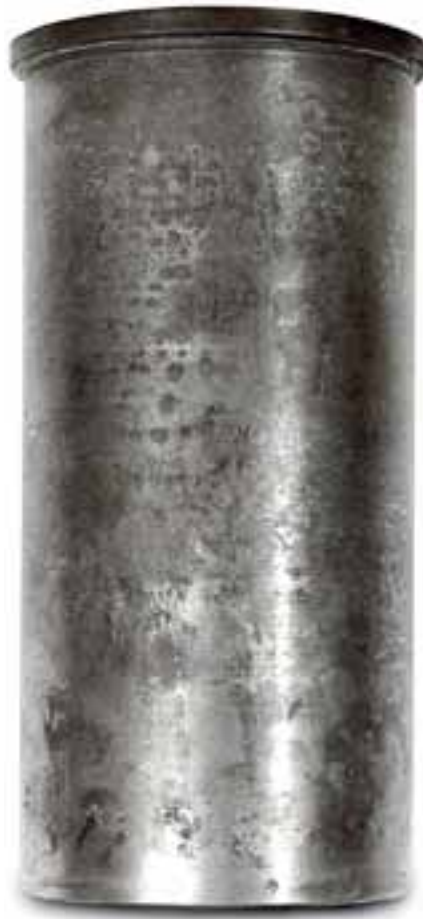
The cylinder bores display an uneven wear pattern with individual brightly polished areas (Fig. 2). No wear or rubbing marks are evident on the pistons. The engine was losing oil at the sealing points, in particular the radial oil seals. Fig. 1 clearly shows the corrosion on the outer diameter of the cylinder liner which caused the out-of-roundness of the cylinder when it was installed.

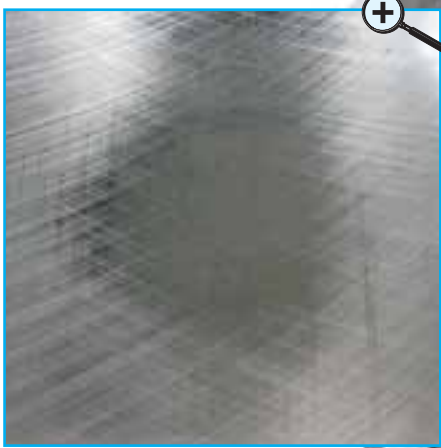
Fig. 2

In its upper area, the cylinder running surface has highly polished, bare areas in which the honing structure is completely unrecognisable (Fig. 1 and Fig 2). There are no significant signs of wear on the piston itself. The engine is consuming increased quantities of oil.

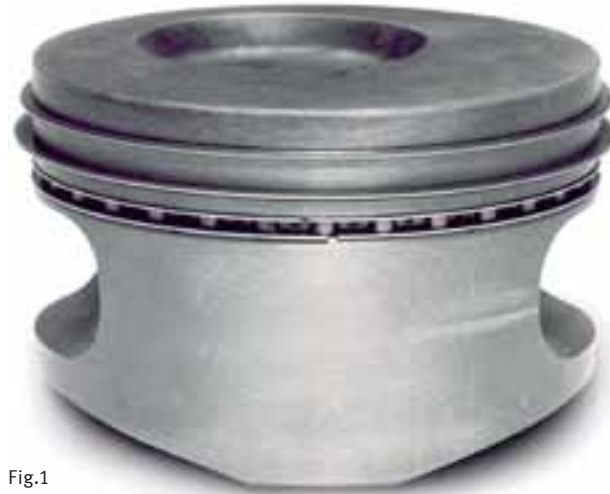
Fig. 1

The rings do not display any visible or measurable wear. No signs of wear are evident on the pistons either (Fig. 1). In this case, the oil scraper ring is a 3 piece oil control ring comprising the expander spring and the two blade rings. Both of the ends of the expander spring should normally be flushed against each other. In this case the expander spring had been installed incorrectly, and the last segment overlapped at the joint (Fig. 2).

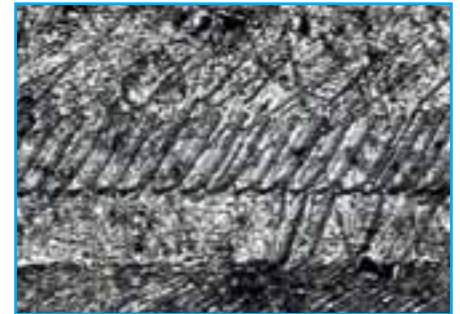
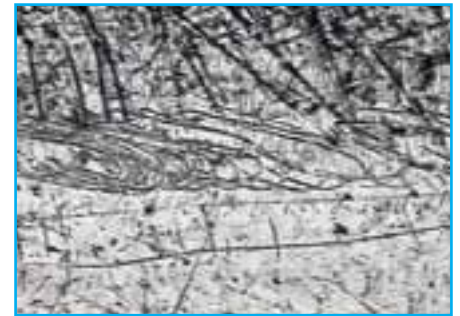
Scratches on the piston and piston rings, a matt wear pattern on the piston skirt, roll marks on the ring flanges (Figs. 6 and 7) and a bulging cylinder wear (Fig. 5) are always the consequence of abrasive foreign bodies in the oil circuit. As the piston rings are worn on the running surfaces and edges, they can no longer seal the cylinder sufficiently and can therefore no longer prevent oil from passing into the combustion chamber. At the same time, the pressure in the crankcase increases as a result of combustion gases flowing past the cylinder. This excessive pressure can cause increased quantities of oil to escape through radial oil seals, valve stem seals and other sealing points.

Roll marks on the rings are caused by dirt particles which become lodged in the ring groove. As the piston ring rotates in the groove, it keeps running over the dirt particle and gradually creates the characteristic marks on the piston ring flanks.

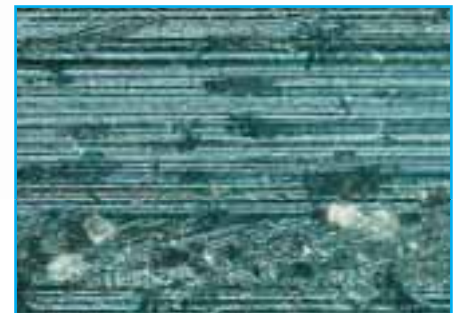
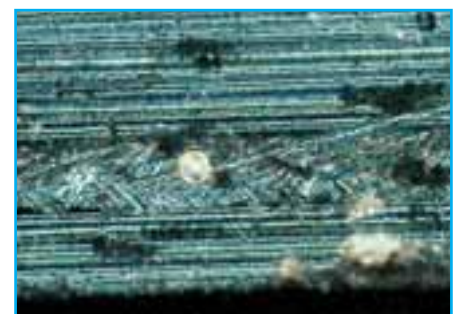
engine is running, thus causing abrasive wear. Figs. 8 and 9 show this type of damage due to dirt. The images were recorded with polarised light under a microscope in our laboratory. Glass fragments and even entire beads of the glass used for blasting can be clearly seen.

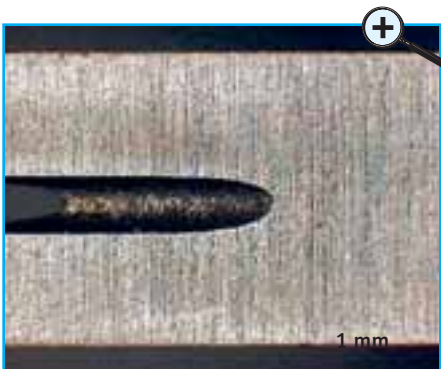
Fig. 2

The piston displays signs of wear on the piston top land and the piston skirt. Rubbing marks can already be seen on the piston skirt which are characteristic for dry-running due to fuel flooding. The piston rings display very severe radial wear (Fig. 1). Both of the webs (support surfaces) on the oil scraper ring have been completely worn down, which also indicates significant wear (Fig. 2). By comparison, Fig. 3 shows the profile of a new and worn oil scraper ring (double bevelled spiral expander ring).

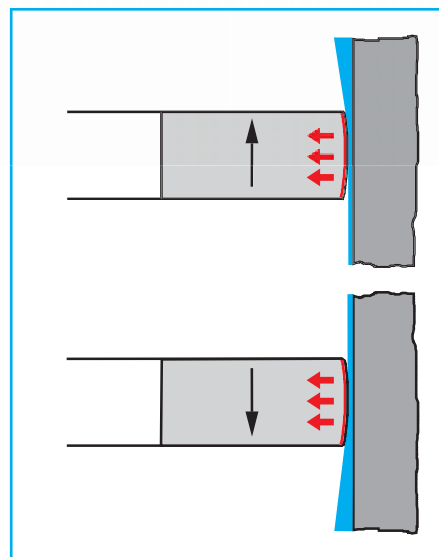
Fig. 2

High hydrodynamic forces arise between the running surfaces of the piston rings and the cylinder running surface as a result of the worn piston ring edges and the consequent formation of a so-called oil wedge (Fig. 2). The piston rings float on the oil film

during the upward/downward motion of the piston and are lifted slightly off the cylinder running surface. In this way, increased quantities of lubricating oil reach the combustion chamber where they are then burned.

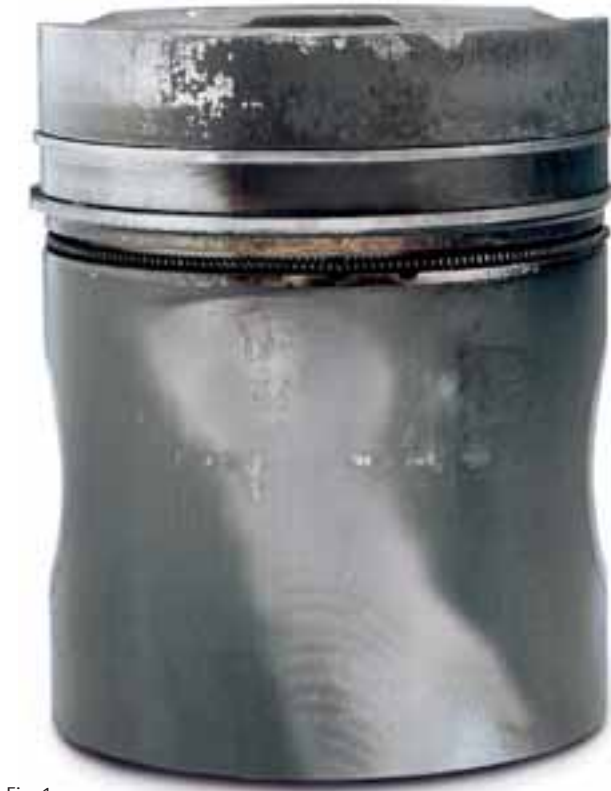
Fig. 1

In Fig. 1, the wear pattern of the piston over the entire piston height is asymmetrical on both sides. The piston top land has been rubbed bare on the left-hand side of the piston above the piston pin bore (left-hand side of the picture), whereas stop marks are evident on the opposite side at the lower edge of the piston. The uppermost compression ring also displays an uneven wear pattern. Load-bearing, shiny surfaces alternate with darker, matt areas with a blue discoloration (tempering colours).

This type of asymmetrical wear pattern indicates that the piston has not been running perfectly straight in the cylinder and that the piston pin axis and the crankshaft axis are not parallel to each other. As a result, the piston only bears against one side, and the piston rings cannot perform their sealing function properly due to the lack of proper con-

oil into the combustion chamber and thus increases oil consumption. Under certain conditions an axial thrust can be applied to the piston pin, which can lead to wear or fracturing of the piston pin circlips. See also point “3.7.1 Piston damage caused by broken piston pin circlips”
